Cobalt intoxication diagnosed with the help of Dr House

Lancet 2014; 383: 574

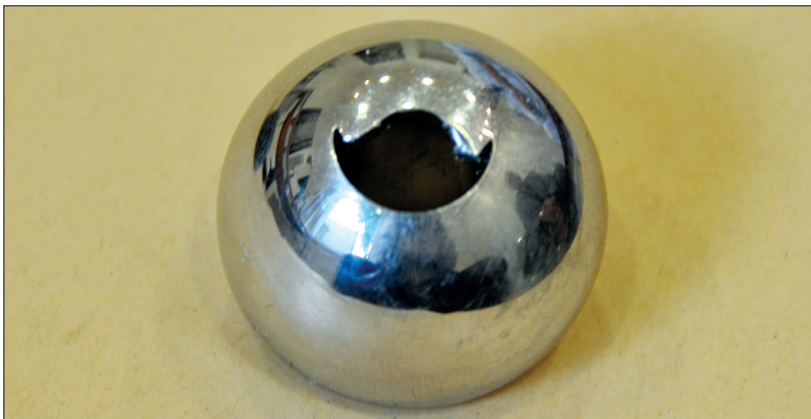
Figure: Metal hip prosthesis causing cobalt intoxication
Removed metal head with hole due to severe metal loss.

Cobalt intoxication has been a well known cause of cardiomyopathy for over 50 years; however, it has mostly been known in the context of so-called Quebec beer drinkers' cardiomyopathy and hard steel work-related exposure to cobalt.^{2,3} The stability of cobalt in combination with chromium and molybdenum (usually Co 70%, Cr 25%, Mo 5%) made this metal an excellent and stable compound in hip prosthetics. Numerous studies have investigated metal exposure due to metal hip arthroplasties.⁴ However, in certain situations—false placement, technical problems in metal-on-metal prosthesis, and strikingly often after an off-label replacement of broken ceramic hips by metal parts—cobalt exposure to the patient from a hip prosthesis occurs. This cobalt intoxication is an increasingly recognised and life-threatening problem.⁵
